## Tree damages in the vicinity of mobile phone base stations

Cornelia Waldmann-Selsam and Horst Eger

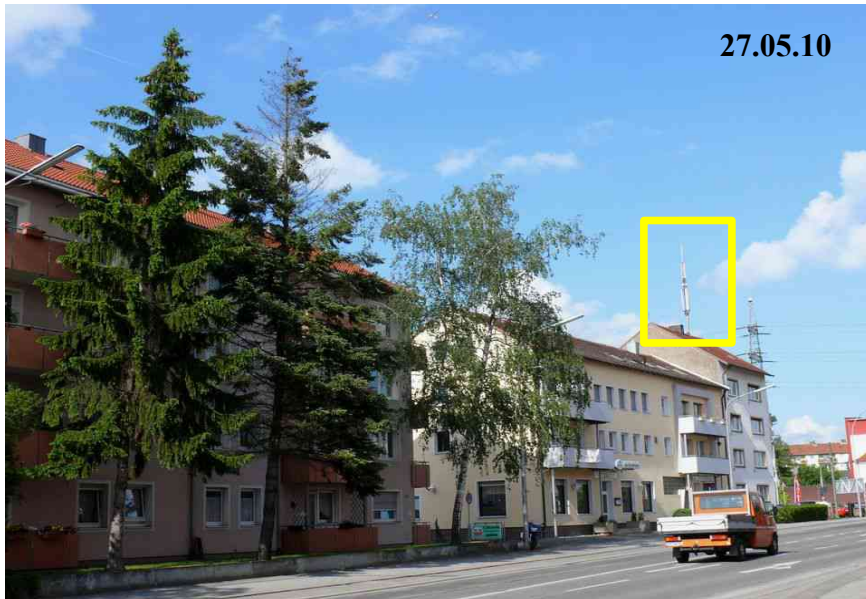
Fig. 3a: 27 May 2010: Two spruce trees and a birch in the radiation field of the mobile phone base station Zollnerstraße in Bamberg in May 2010. The spruce facing the transmitter has lost many needles in the upper part. The birch does not grow upwards (Photo: C. Waldmann-Selsam).

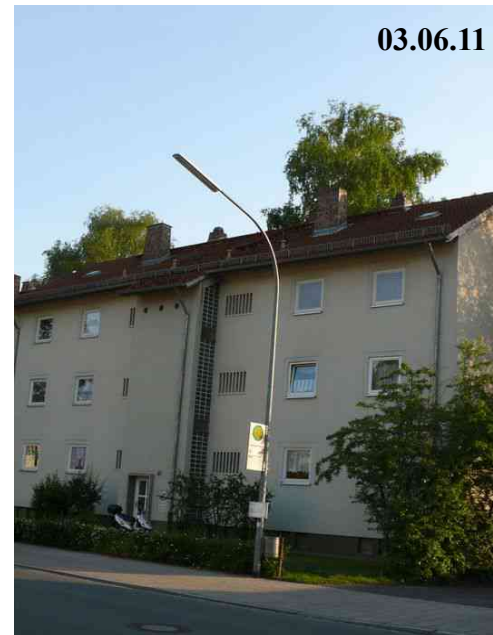
Fig. 4a: 8 July 2008: Unilaterally damaged and already trimmed maple with visual contact to the base station Hauptsmoorstr. 26 a in Bamberg (Photo: C. Waldmann-Selsam).

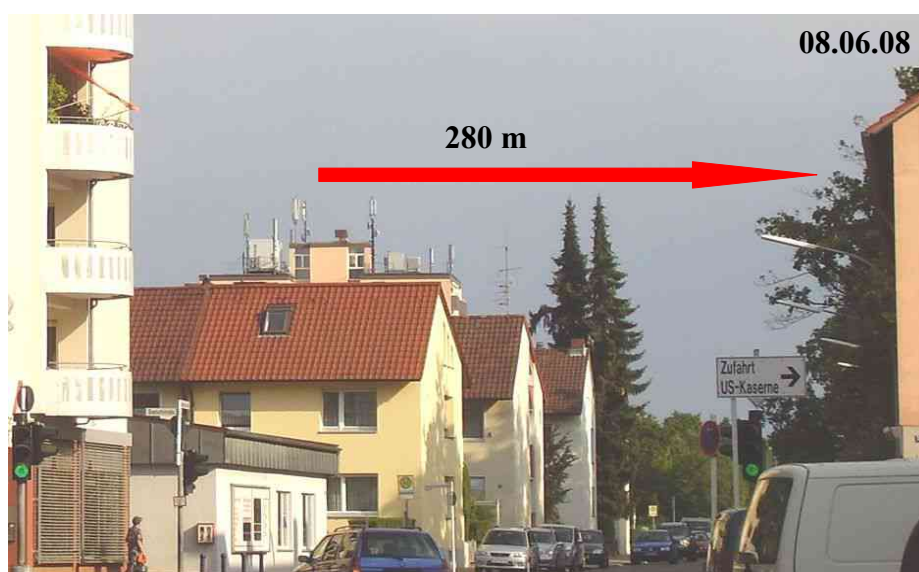
Fig. 4c: 8 June 2008: View from the crossing Hauptsmoorstraße/ Seehofstraße on damaged maple to the right, mobile phone base station Hauptsmoorstr. 26 a and two conifer trees with growth disturbance on the top (Photo: C. Waldmann-Selsam).

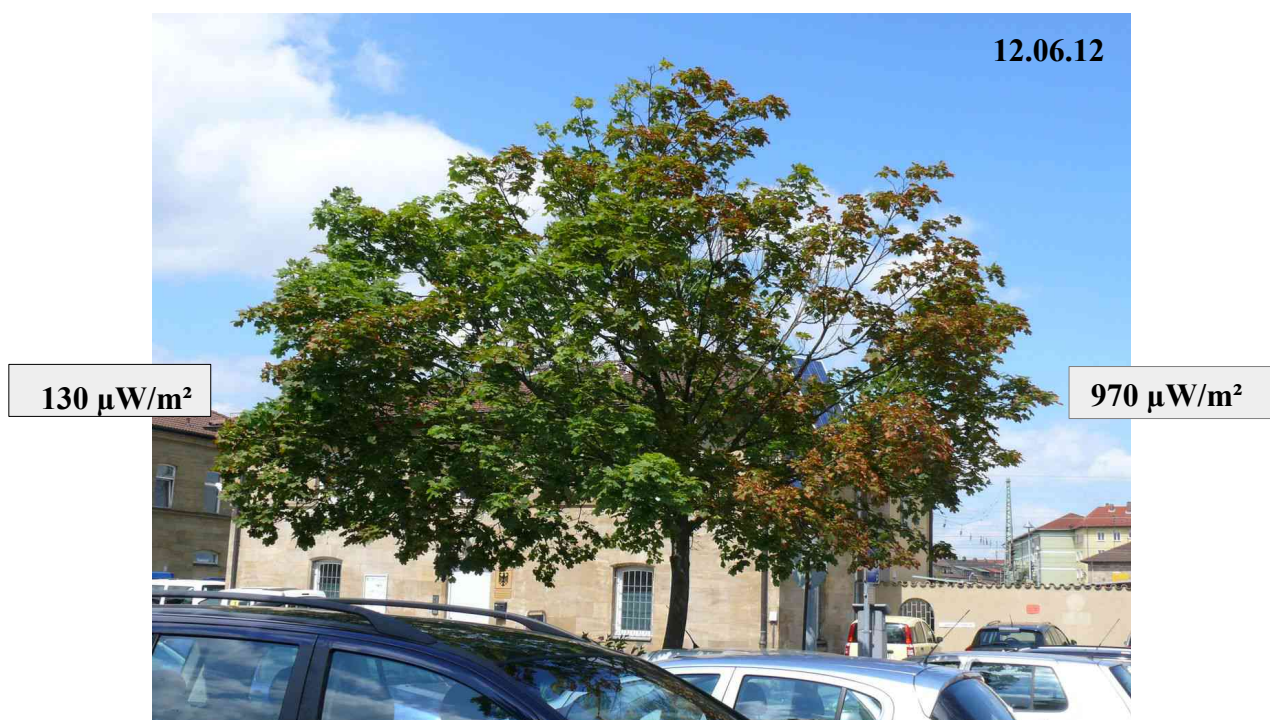
Fig. 5: 26 June 2012: One-sided damaged maple tree on a grass verge at the parking of the railway station in Bamberg. There is visual contact (to south and west) to mobile phone base stations. The measurements in a height of 3 meters showed considerable differences between the south and the northeast side: south side  $970 \mu\text{W}/\text{m}^2$ , northeast side  $130 \mu\text{W}/\text{m}^2$  (Photo: C. Waldmann-Selsam).

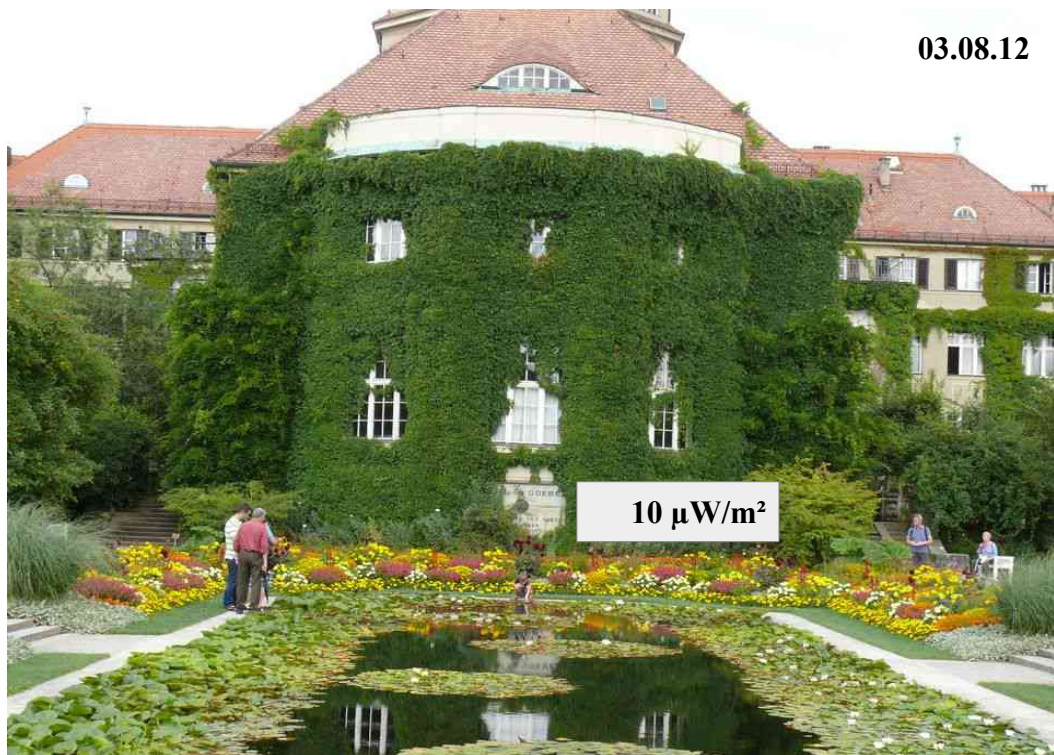
Figure 8a: 3 August 2012: South facade of the Botanical Institute of the Ludwig Maximilian University in Munich with dense vegetation of Virginia creeper. Result of the measurement:  $10 \mu\text{W}/\text{m}^2$  (Photo: C. Waldmann-Selsam).
